Looe Heritage Guidance Notes

No. 2: Roofs and Rainwater Goods

These Guidance Notes have been produced by Caradon District Council as part of the Looe Heritage Economic Regeneration Scheme (HERS). The views expressed are intended to stimulate discussion and the adoption of positive approaches in the town.

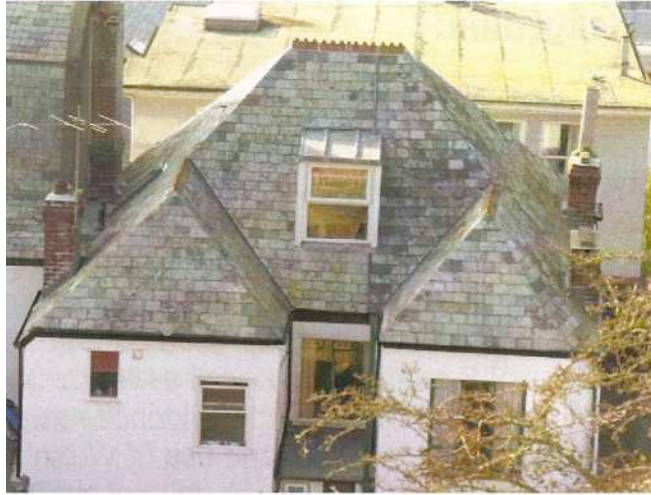
Fig 1: A U-plan roof in sized Delabole slate with mitred hips

The technical limitations and joinery skills available meant that such buildings were initially only one room deep. Not so many examples remain in the town as there was much adaptation and re-building, especially in the 19th and 20th centuries. Buildings of the 17th and 18th centuries span deeper plans with the traditional A-frames and the simple vernacular roof lends itself to extension into T, L or U forms using the same basic tried and trusted methods. *[Fig 1]*

Lead was expensive and clay tiles hard to come by so slaters became skilled at cutting and using slate creatively to achieve weathertight edges, [see Fig 1] The mitred hip is one of those methods that has a practical origin but deserves to be continued as it is simply more attractive. A hip with clay tiles appears heavy and the eye is drawn to the tiles; [Fig 77] whereas a mitred hip has a visual flow and accentuates the quality and beauty of the slate. Mitred hips are the traditional method and ought to be used in preference to tiled hips in most situations.

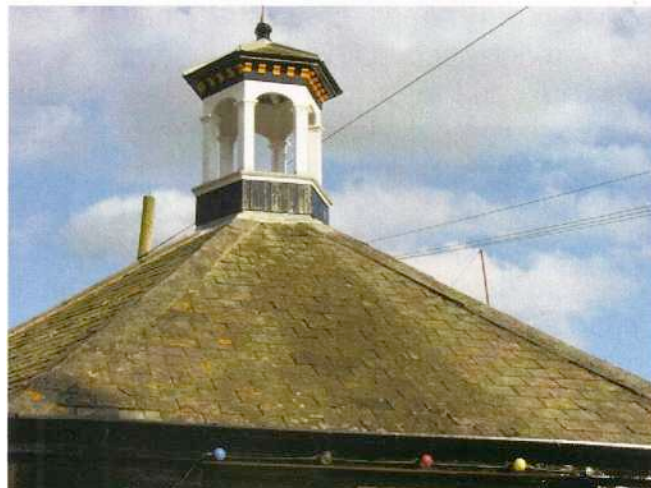
Fig 2: The Butter Market roof in West Looe

Occasional oddities can be seen in the town, such as the mansard roof on the Swan Hotel and the hexagonal butter market. *[Fig 2]* Whilst these are part of the historic character of the Conservation Area they cannot be used to justify similar approaches on new developments.

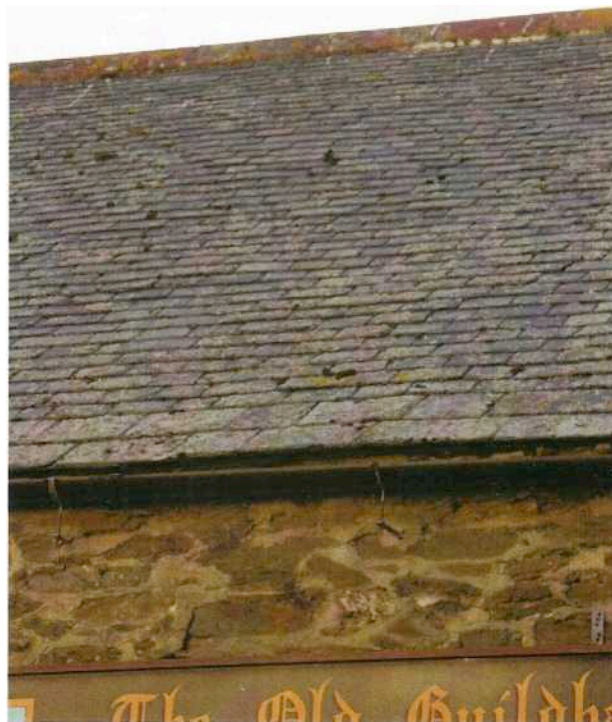
Fig 3: Traditional roof on the Old Guildhall with slate laid in diminishing courses

The term 'scantle' is applied to a variety of roofing techniques that all involve the use of slates in varying size. Much larger slates are used at the eaves and on the verges to offer more resistance to wind; the rest of the roof is filled with smaller slates having a general reduction in size towards the ridge. *[Fig 3]* This was a very efficient use of materials as virtually any piece of slate could be incorporated somewhere on a roof. A further characteristic of scantle slating is that the slates are hung onto riven laths using wooden pegs and bedded onto lime mortar laid on the head of the course below.

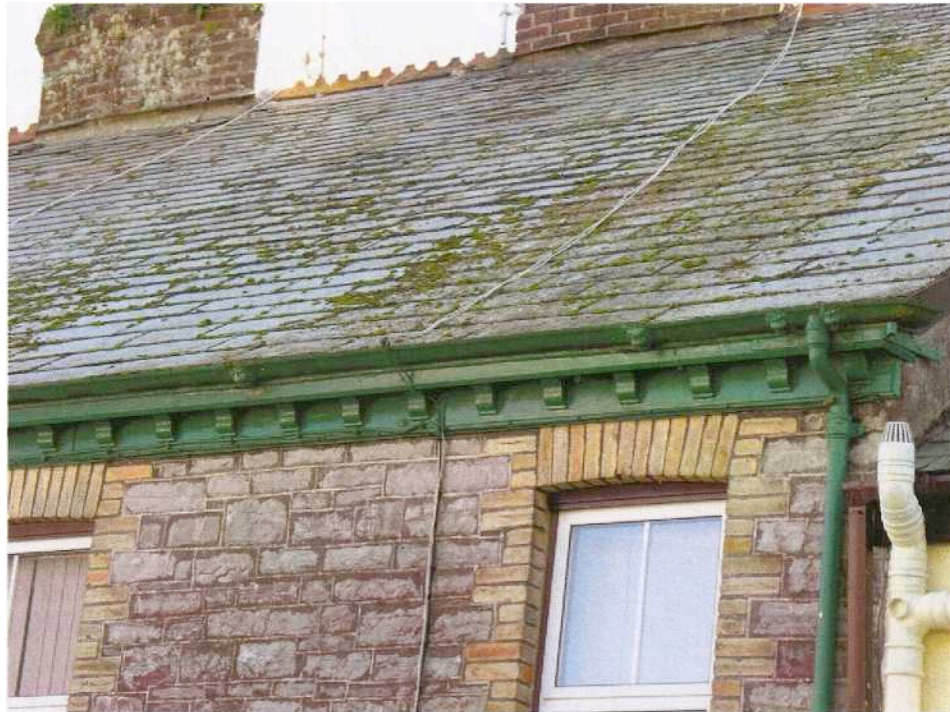
Fig 4: Ordered diminishing courses in Delabole slate have great character

A common feature of both rag and scantle roofs is that the slate is laid in random widths and diminishing courses - though in both cases this can be a bit haphazard depending on the slate available and the preferred methods of the slater. During the 19th century this tradition was refined and eventually set out as a defined system. The 'Delabole System' allowed the skilled slater to plan the gauge for battens once the slates had been sorted and stacked in various lengths. There are some examples of such ordered roofing in Looe but this is a rarity. [Fig 4]

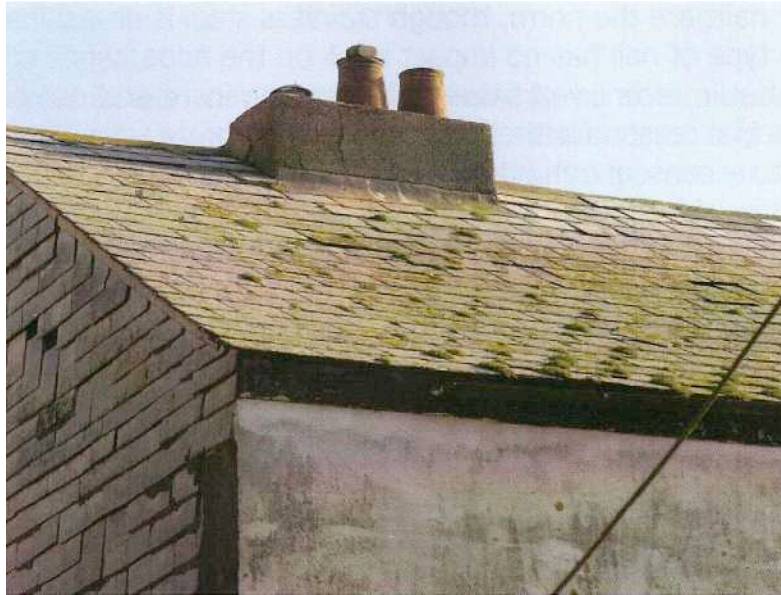
Fig 5: Sized Delabole slates with slippage due to nail rot .many of the slates could be re-fixed though

The 19 th century saw the use of pegs decline and iron nails became ubiquitous. This in itself causes problems over time as the iron nails tend to rust and fail long before the slate itself shows significant signs of wear, [see Fig 5]

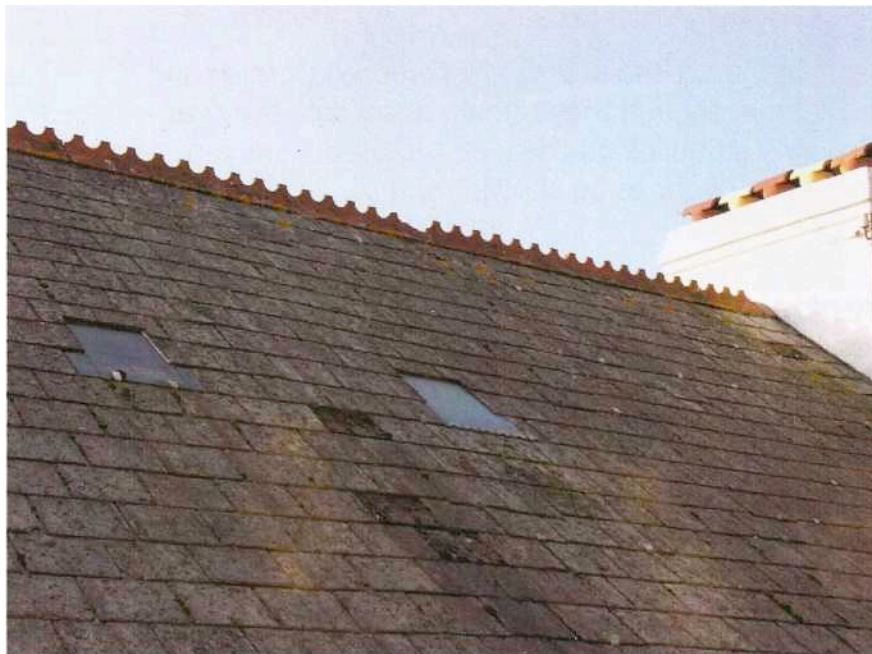
Fig 6: Crested red clay ridge tiles

By the 19th century a range of clay ridge tiles were available; the most commonly used were plain red clay or glazed blue/black varieties. More decorative styles became available - crested, pierced and so on. [Fig 6]

For over 150 years rooflights have been used to allow light and ventilation of roofspaces. Historically they were cast iron and quite small; they were also used with discretion to provide just enough light and normally on less sensitive roofslopes. Quite often a sheet of glass was set into slate to provide illumination of a roof void and this can still be a valid solution in some situations, [see Fig 6]

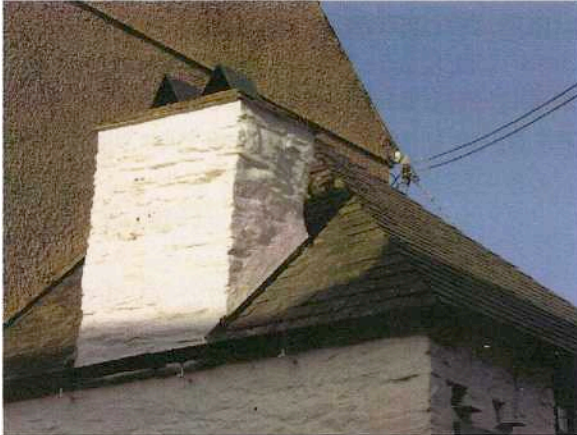
Fig 8: Half round cast iron guttering fixed using spiked brackets, so avoiding the need for a fascia board

The majority of old vernacular buildings in Looe have minimal overhang at the eaves. Gutters are sometimes fixed directly onto rafter ends or on brackets spiked into stonework. [Fig 8] Fascia boards are generally simple, shallow

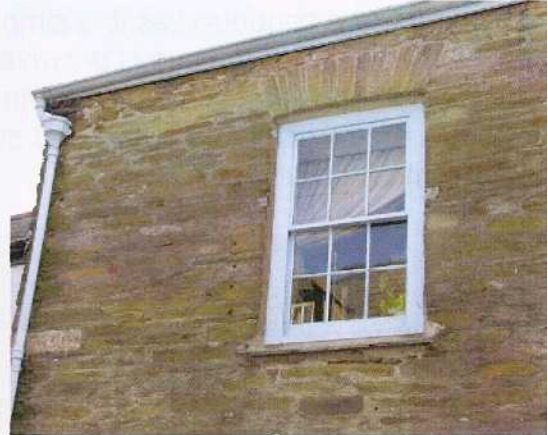
Fig 9: Ogee cast iron guttering fixed to a shallow fascia with no overhang or soffit

and fixed tight to the wall. [Fig 9] Recent years have seen the introduction of box soffits when re-roofing takes place. This is usually detrimental as it gives a heavy look and often creates a deeper shadow line that exaggerates the effect.

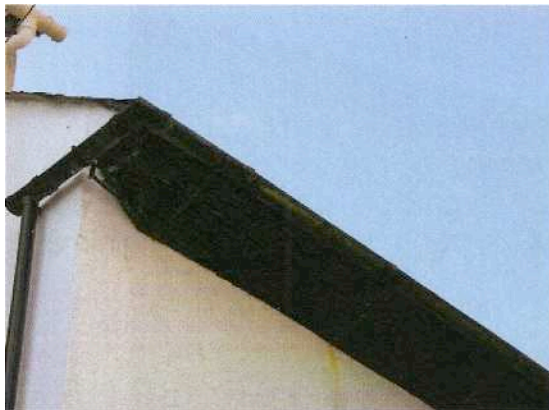
Fig 10: An ornate dentil cornice but black paint makes the detail less apparent

Many of the buildings constructed or re-modelled in the 18th and 19th centuries had greater architectural aspirations and decorative eaves were a popular form of embellishment. Larger overhanging eaves with decorative brackets or substantial cornicing add visual interest to these buildings, especially when viewed from the more intimate streets. [Figs 10 & 11]

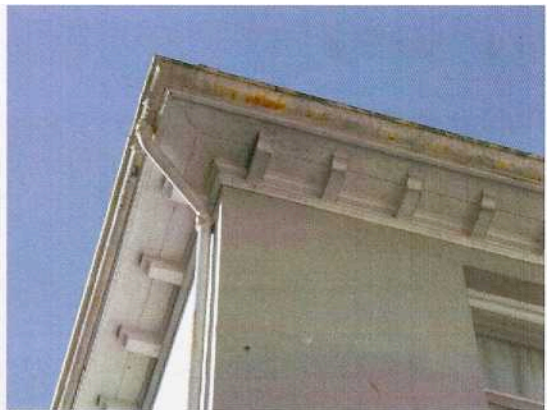
Fig 11: An overhanging bracketed eaves with boarded soffit

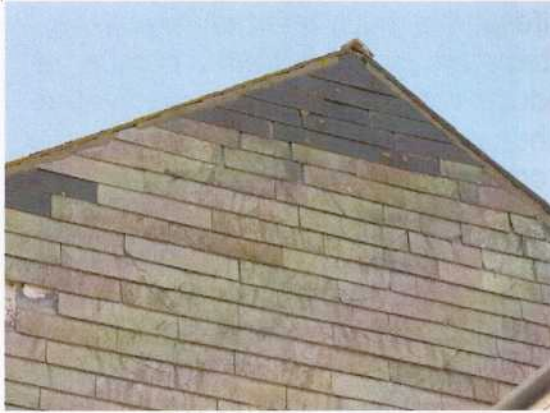
Fig 12: A simple mortar fillet between the roof and rag slated gable end (note that slate is hung back-to-front to give a natural drip)

The local tradition is either for the roofing slate to be laid tight to the top of the wall, with render or a mortar fillet seal [Fig 12] or a course of vertical slates fixed to the wall and abutting the underside of the overhanging roof

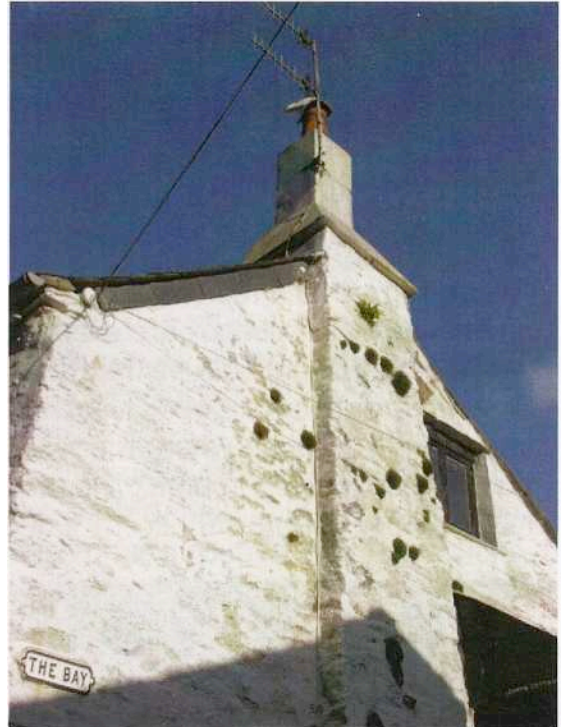
Fig 13: This roof has slated and unslated verges

slates. [Fig 13] Sometimes slate is simply added to the purlin ends for weather protection.

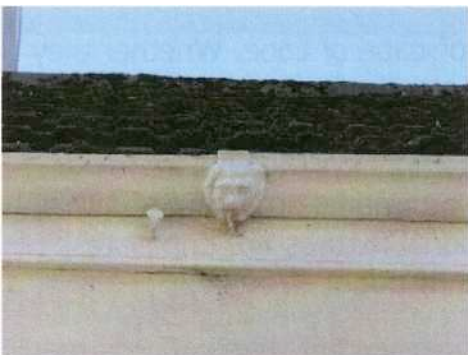
Fig 14: Lions heads on ogee gutters are relatively common in Looe

The historic form of gutters in the town was simple half round or ogee profile, emptying into simple round section downpipes. Cast iron was the ubiquitous material and so an element of continuity was apparent, unifying the eaves lines throughout. Ogee gutters occasionally have lions head motifs which add interest and ought to be kept. [Fig 14]

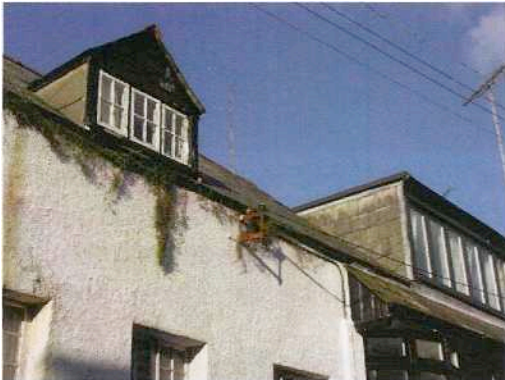
Fig 15: If gutters are not cleared of debris plants soon take over and the rainwater spills over the face of the building [see also Fig 20]

Failure to maintain rainwater goods causes more harm to historic fabric than anything else. Blockages are exacerbated by gull droppings and vegetation can soon take hold and ensure that rainwater spills onto walls. [Fig 15] Breakages and leaks can deliver the water collected from a large area of roof into a single location where the results can be most destructive. It is a question of 'a stitch in time'; the false economy of missing regular maintenance can be very costly indeed. [Fig 16]

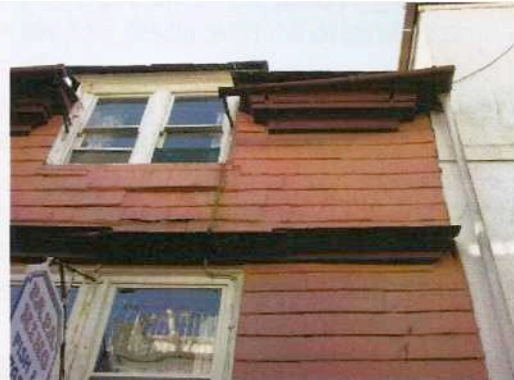
Fig 16: This broken gutter fixing has clearly been discharging water onto a very important historic facade for some time. It is causing costly damage to slate hanging, cornice and probably structure; it is also a potential danger to pedestrians below

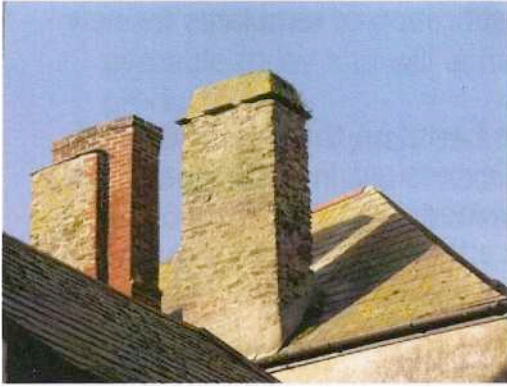
Fig 17: Chimneys add interest to roofscape and suggest phases of historical development

Chimneys add considerably to the distinctive roofscape of Looe. Whether they are substantial stone stacks, the more common slender brick ones, or a combination of the two, they all tell a story about the historic development of a particular building. [Fig 17] For the most part chimneys in Looe are fairly simple, sometimes notably so; but there is also occasional ornament and this variety is a feature in itself, [see Fig 19] Traditional fixtures like drip slates, pots and cowls all add diversity and interest - they ought to be kept whenever possible. [Fig 18]

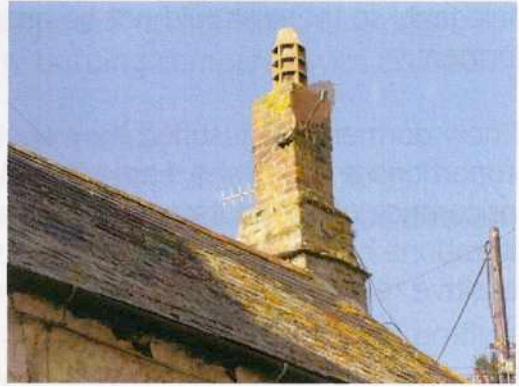
Fig 18: A traditional tapered stone stack with slate drips, later raised in brick with a functional pot

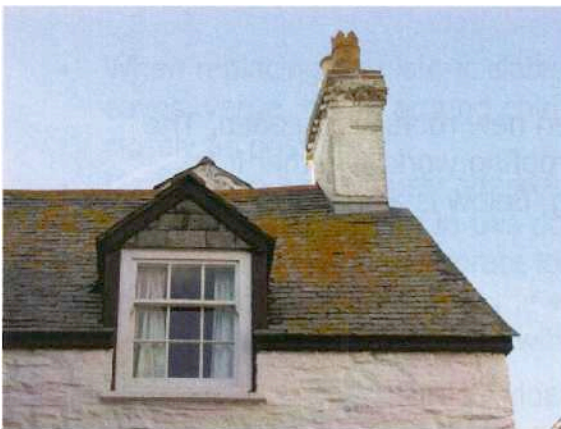
Fig 19: An attractively detailed eaves dormer is a later addition. Note the absence of guttering and simple moulded edges to fascia and barge boards

Dormers are not a prevalent feature of the town, but they do appear here and there. Some were designed as part of a building but most were 19th century additions. Styles vary but historic ones tend to be attractively proportioned and some retain good details. Eaves dormers are more common than true roofslope dormers, some are gabled, [Fig 19] others are hipped. [Fig 20]

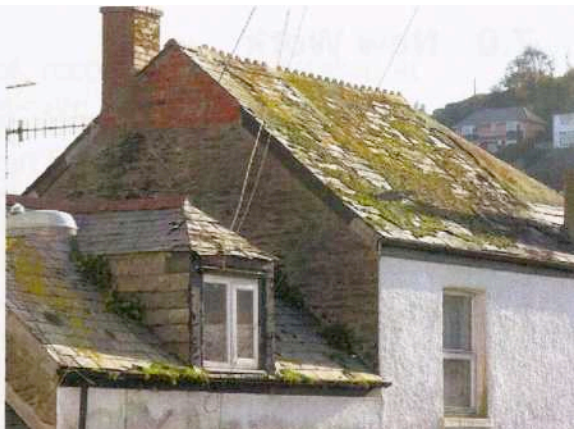
Fig 20: Hipped dormers are less visually assertive than gabled ones

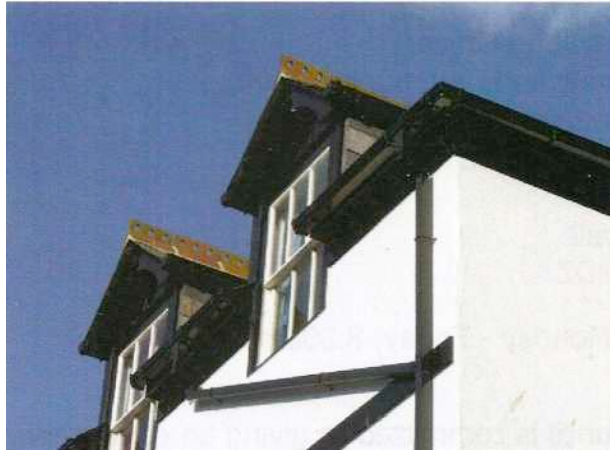
Fig 21: This plastic ogee guttering is not even close to the elegance of the historic version; the unnecessarily complicated down pipes in box profile are an unattractive addition

- Traditional clay ridge tiles are most common.
- Lead should be used in accordance with best practice standards established by the Lead Sheet Association. It should always be treated with patination oil.
- Cast iron rainwater goods in half round or ogee profiles are characteristic. If PVCu is used it ought to be in these traditional profiles and in black rather than white, grey or brown.
